D-Day

TANK WARFARE

ARMORED COMBAT IN THE NORMANDY CAMPAIGN JUNE-AUGUST 1944

Steven J. Zaloga and George Balin

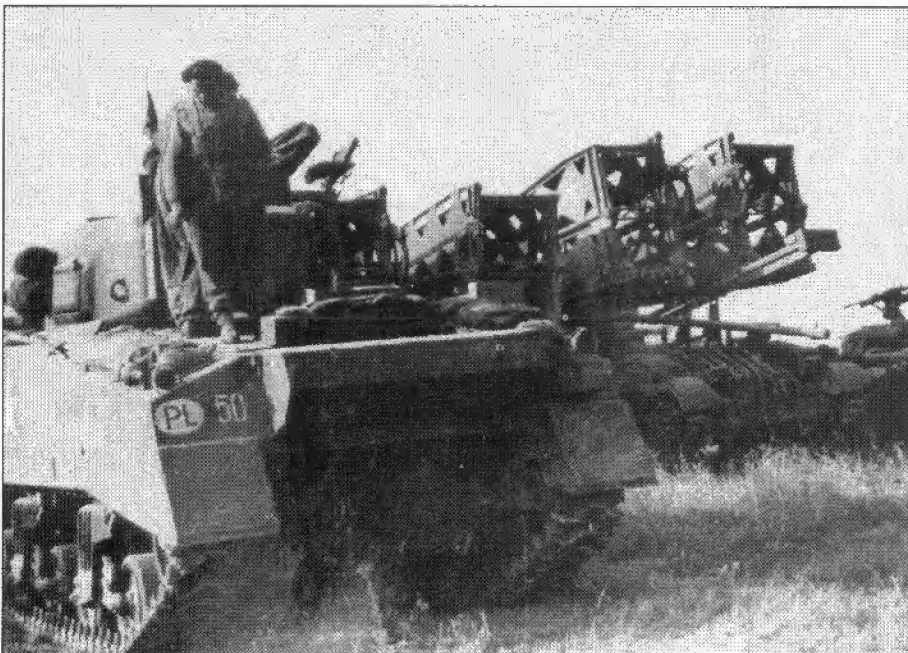
The Polish 1st Armoured Division used some of the less common types of specialized equipment in Normandy, like this Valentine bridgelayer seen behind a Sherman V of 10th Armoured Brigade headquarter troop. The Poles used the European automobile oval insignia for national identification; next to it is a white 50 on a red square which indicates the 10th Armoured Brigade HQ. (Sikorski Institute)

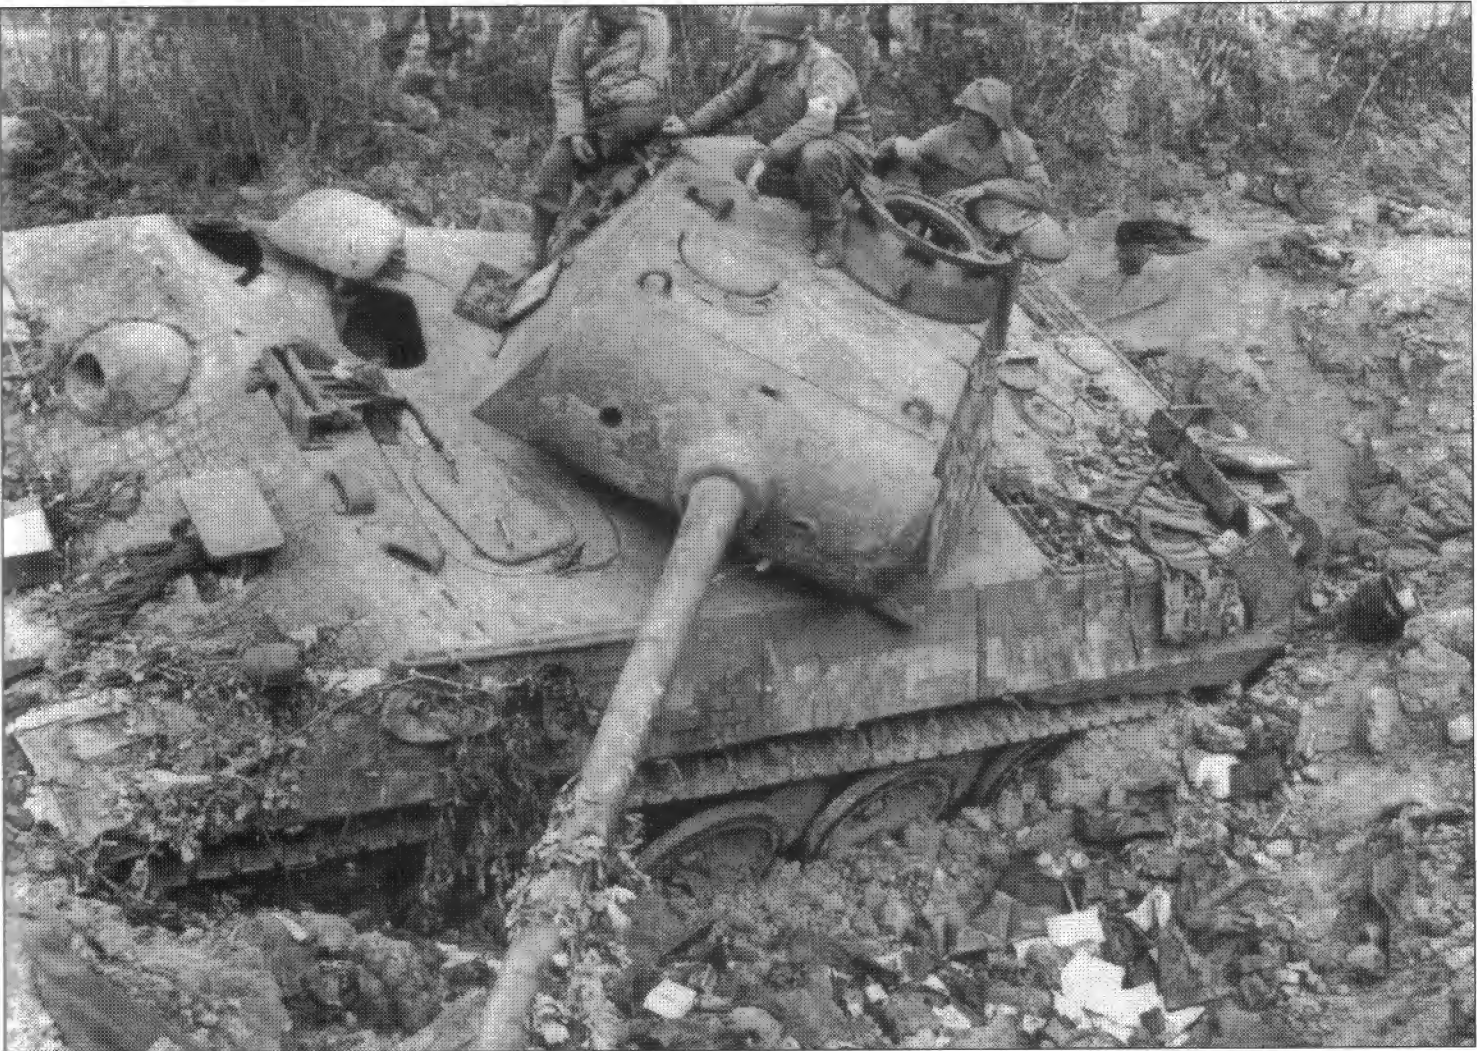
On 25 July, the US Army First Army began a major breakout operation south from St. Lo, called Operation Cobra. The attack was preceded by a heavy bombardment which wrecked the opposing Panzer Lehr Division. This Panther Ausf. A was a victim of the preparatory bombardment: note the shattered armor on the right front corner of the hull, probably caused by a bomb or aircraft rocket. (US Army)

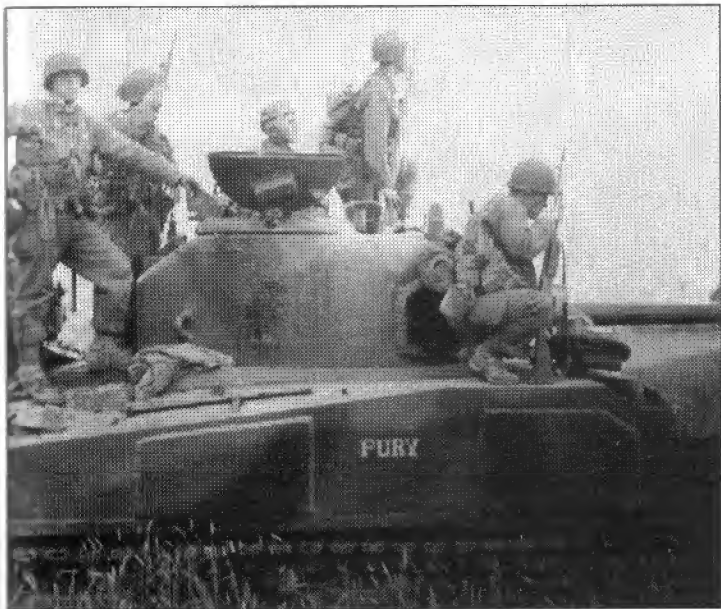
"Fury", a M4 of the 2nd Armored Division, moves forward during the Normandy offensive with infantry onboard. This gives a good view of the applique armor added to the Sherman turret and hull side; the hull panels covered the ammunition racks. (US Army)

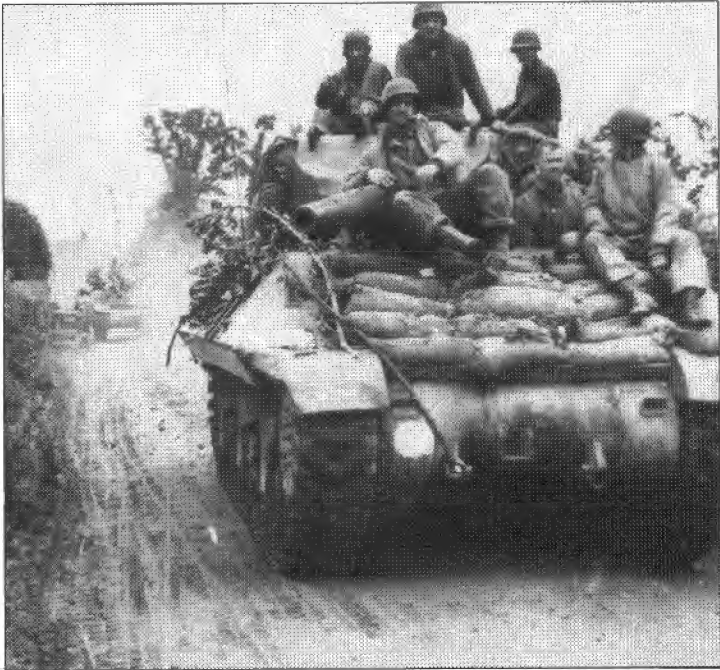
A M10 tank destroyer moves forward from St. Lo during the preparations for Operation Cobra. The M10s and M5 light tanks were among the first US armor vehicles to sport sand-bags to reinforce their thin armor. (US Army)

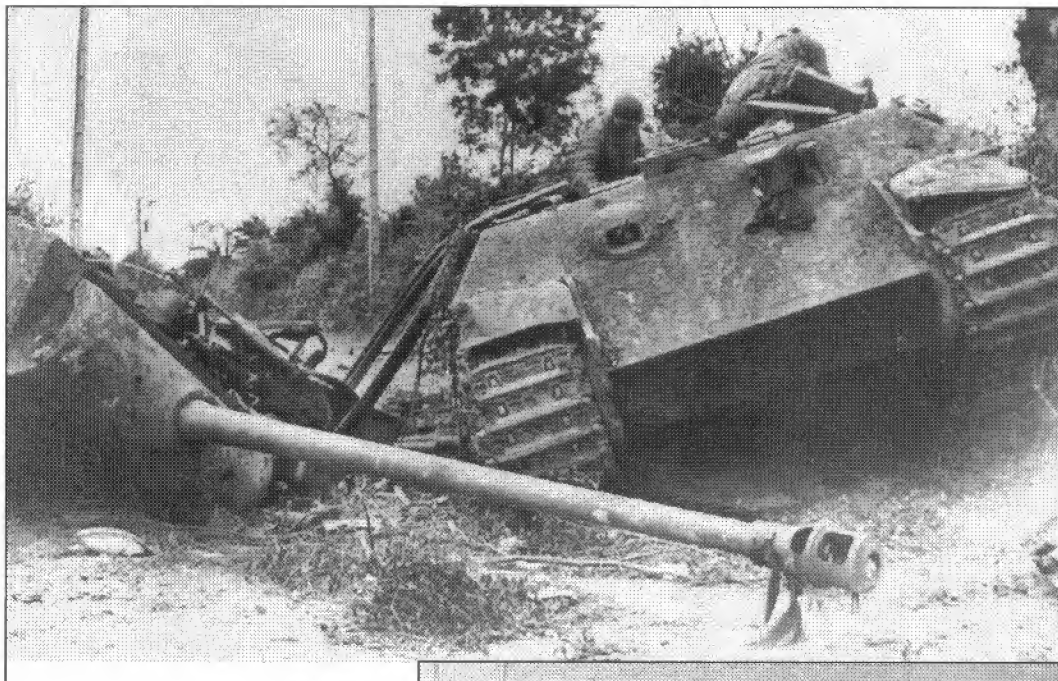
Two GIs inspect a decapitated Panther Ausf. A. This level of damage could only have been accomplished by a catastrophic internal ammunition explosion, usually caused by a penetration of the hull armor by tank fire. (US Army)

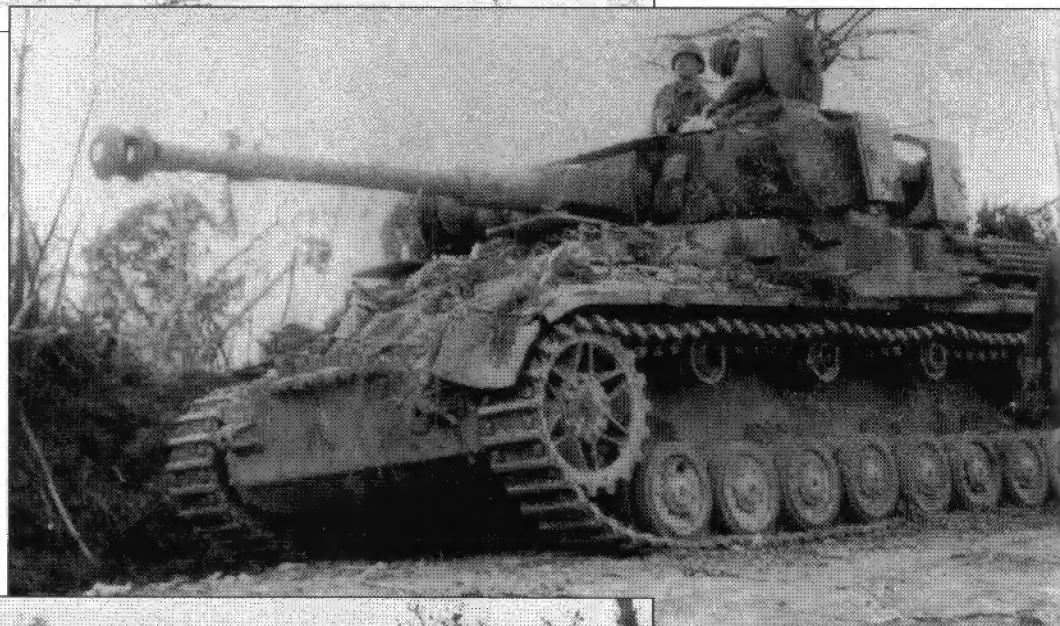
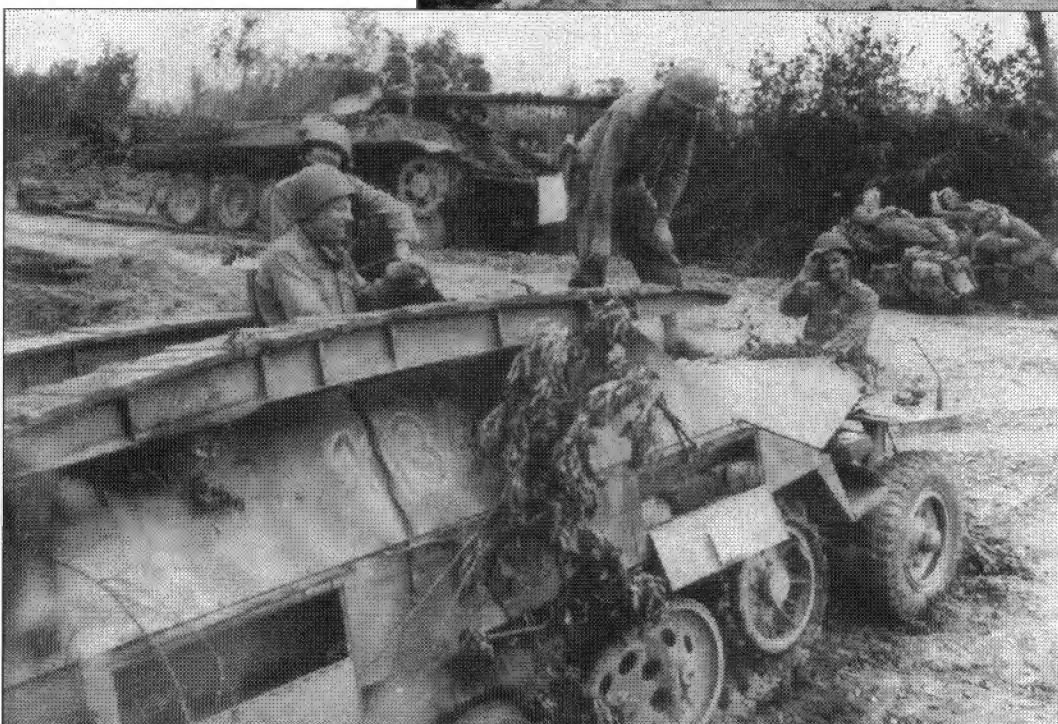
GIs examine knocked out German armor on 26 July during Operation Cobra on the road to Periers. The nearest vehicle is a Sd.Kfz. 251/7 engineer vehicle with a small gap-filling bridge mounted on the superstructure. In the background is a knocked out Panther Ausf. A. Both vehicles were probably from Panzer Lehr Division. (US Army)

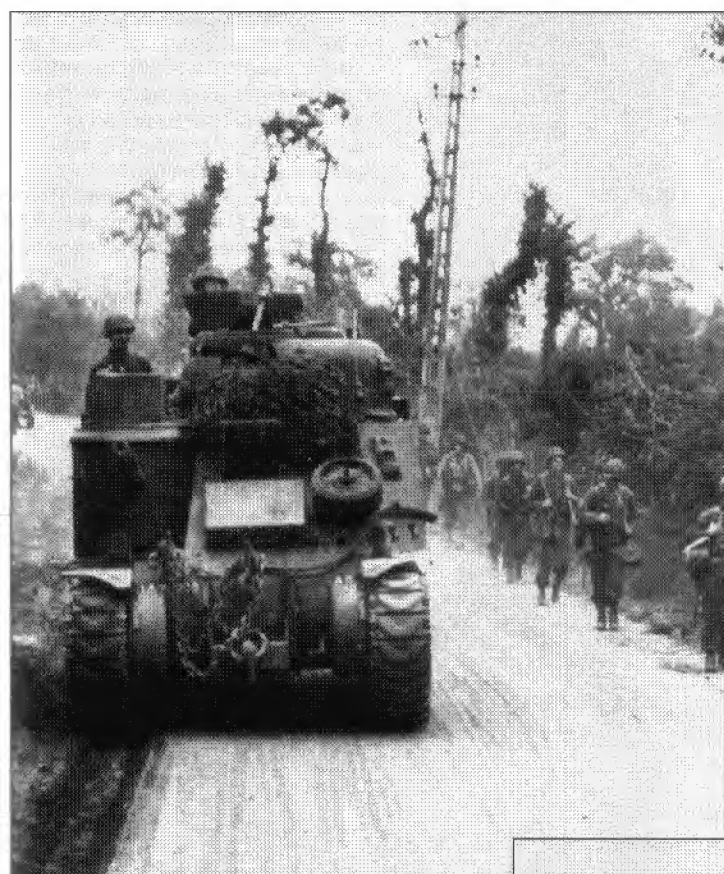
This photo taken on 26 July gives a good impression of the bocage country, with dense hedgerows on either side of this road. The vehicle is an M31 armored recovery vehicle, the only significant version of the obsolete M3 medium tank to be employed by the US Army in Normandy. (US Army)

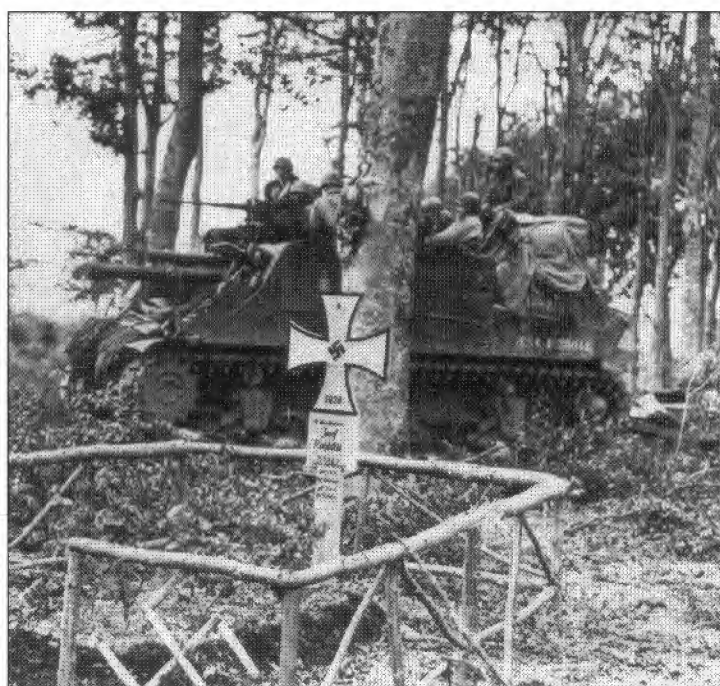
An M7 105mm HMC moves through a small woods on 29 July during the breakout. In the foreground is the grave of a German artilleryman from SS-Art. Rgt. 17 killed in the earlier fighting. Artillery was the one combat arm where the US had unquestioned technical and numerical superiority over the Germans. (US Army)

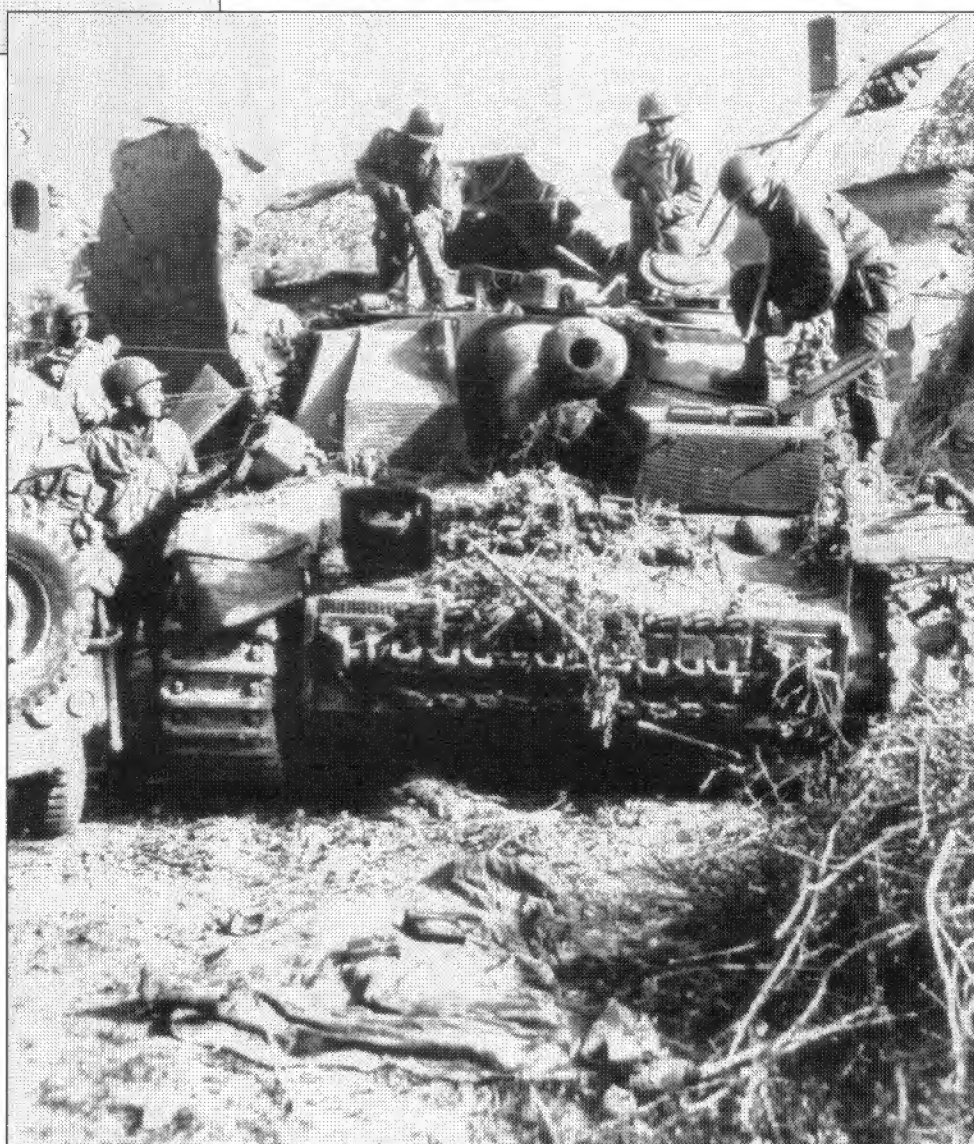
US troops inspect a destroyed StuG IV on 29 July during the breakout. This assault gun was based on the Pz.Kpfw. IV chassis instead of the more common StuG III on the Pz.Kpfw. III chassis. The troops are probably looking for booby-traps, which was a common German ploy when abandoning equipment. (US Army)

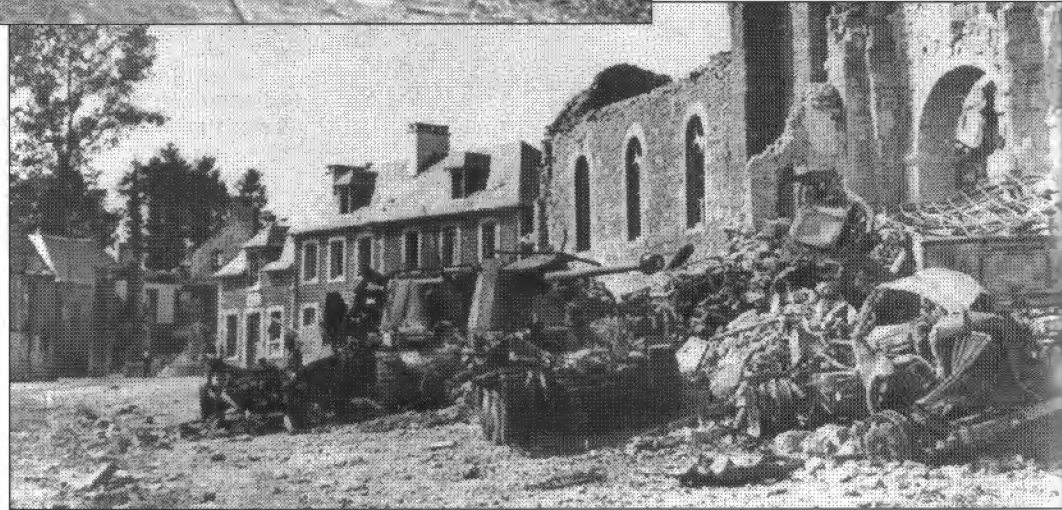
Roncey was a key town sandwiched between the 2nd and 3rd Armored Divs. during Operation Cobra. Here is a view of a pair of 7.5 cm Pz.Jaeger 38(t) Ausf. M (Sd.Kfz. 138) tank destroyers of the SS-Pz.Jg.Abt. 2 of the 2.SS-Pz.Div. lying amidst the wreckage of the town church in Roncey on 30 July 1944. These vehicles were probably knocked out by air strikes. (US Army)

Another view of Roncey on 1 August as troops of the 3rd Armored Div. pass through. This photo is taken from the opposite end of the church, and the rear of one of the tank destroyers seen in the previous photo is evident immediately behind the US M3A1 half-track personnel carrier. Also in the wreckage is a destroyed Sd.Kfz. 7 fitted with a quadruple 20mm anti-aircraft gun, one of the most effective German air defense weapons in Normandy and the bane of Allied fighter bombers. The M3A1 half-track is towing a 37mm anti-tank gun, a weapon wholly inadequate by 1944. (US Army)

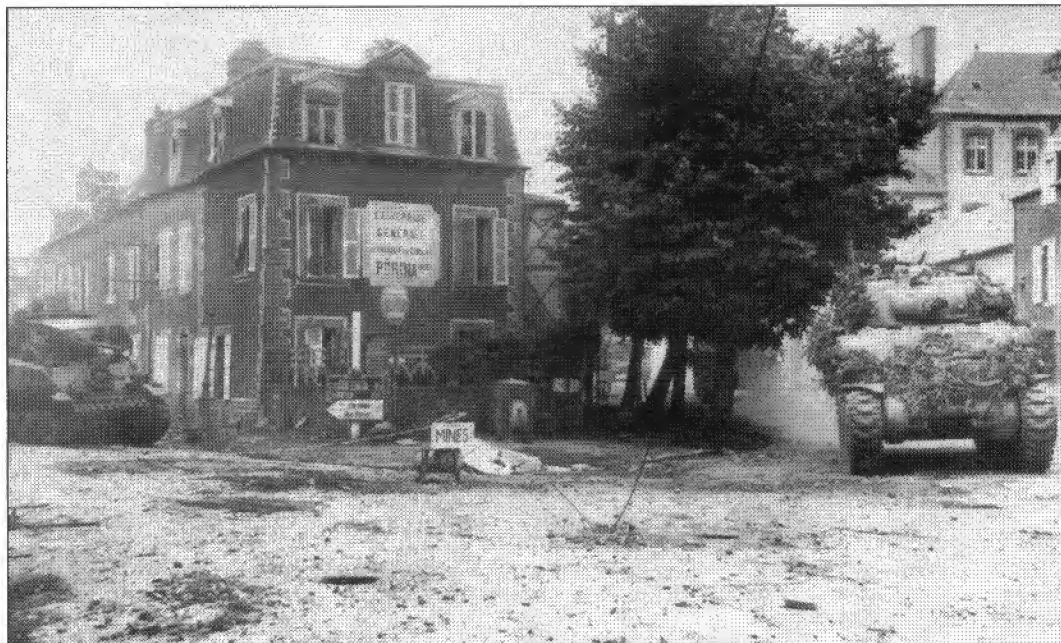
A M4 medium tank of 4th Armored Div. makes its way through Coutances on 30 July 1944. The city was taken by 4th Armored Div. on the evening of 28 July and to the left is a M5A1 light tank that was disabled during this operation by a mine which blew off its right track. Engineers have subsequently taped off the wreckage and placed a sign warning off other units. (US Army)

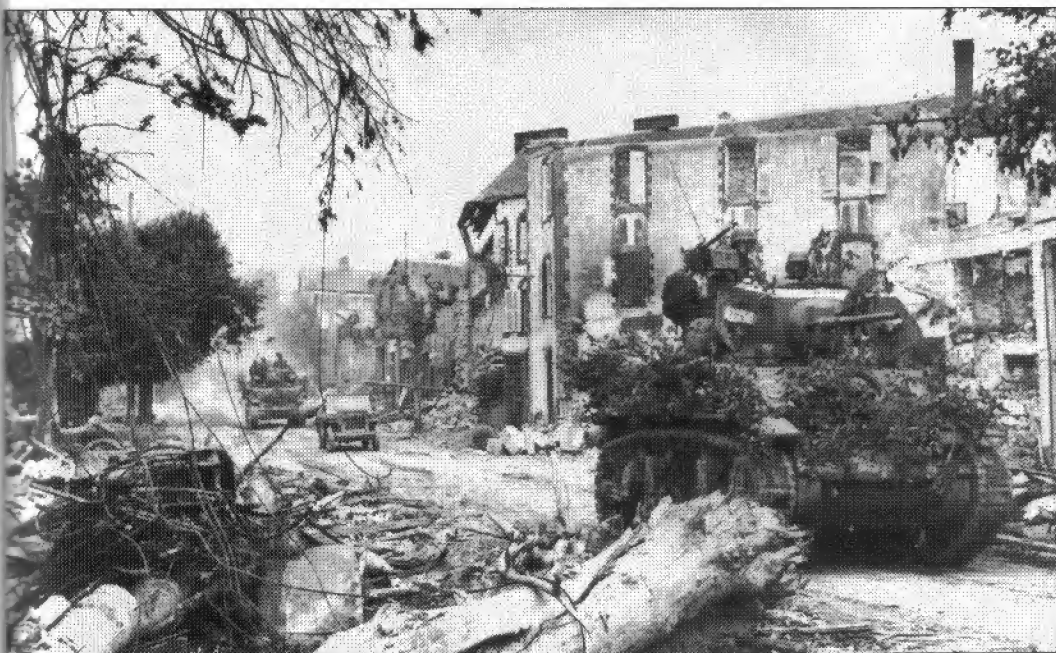
A M5A1 light tank makes its way through the ruined streets of Coutances on 30 July. Several of the battalions of this division festooned their tanks with foliage camouflage before the breakthrough as is very evident on this light tank. By Normandy, the M5A1 light tank was hopelessly armed, and its 37mm gun was effective only against lightly armored German vehicles. The better armed M24 light tank did not appear until December 1944. (US Army)

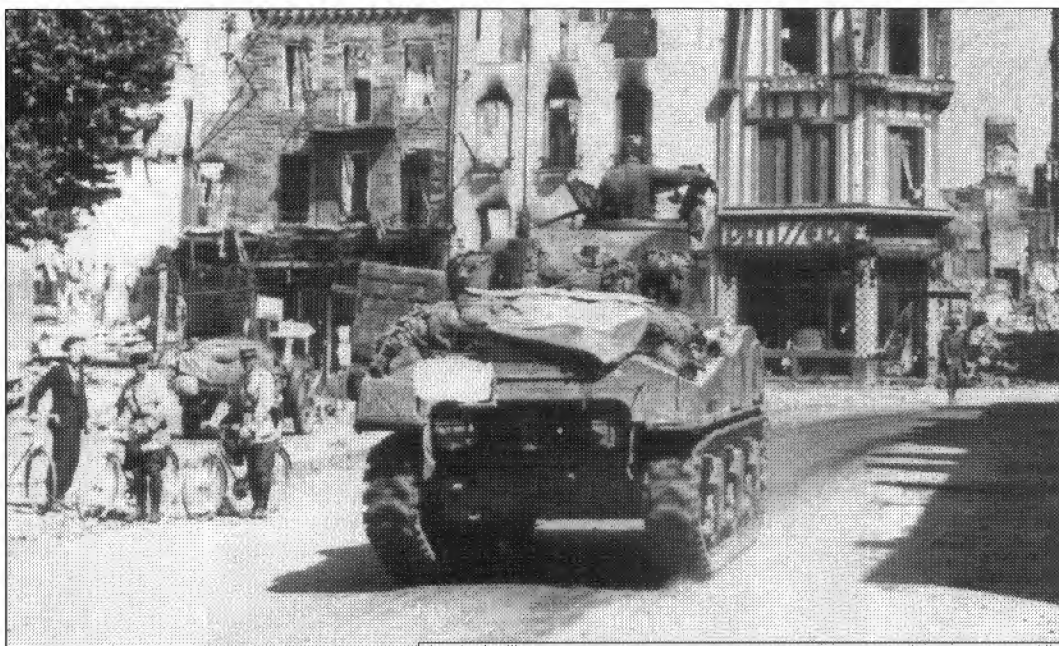
A M4 medium tank of 6th Armored Division passes through Avranches on 31 July. Both 4th and 6th Armored Division had swept south along the coast, meeting at Avranches, before proceeding west towards the key seaport of Brest. On the engine deck of this tank is a fluorescent identification panel, a standard Allied air identification symbol used to prevent attacks by Allied aircraft. (US Army)

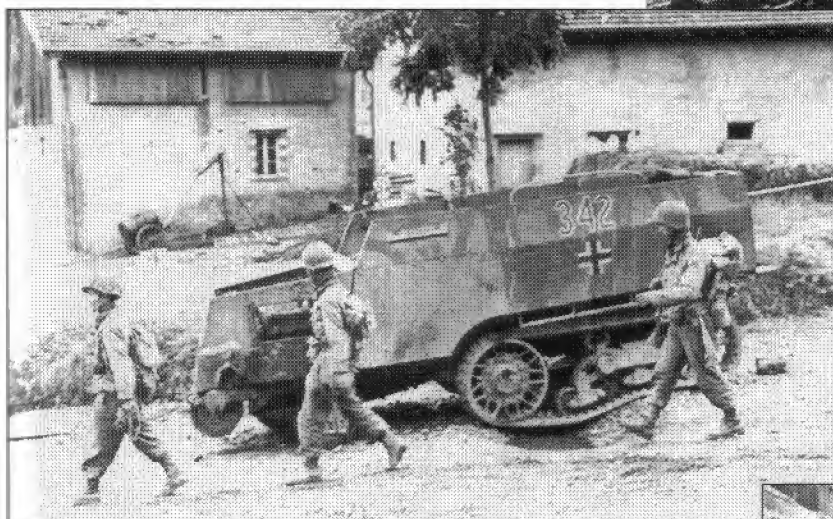
US infantry marches past an abandoned German Schutzenpanzerwagen U 304 (f) which was a local improvisation based on French Unic P 107 half-tracks. This half-track has lost its front left wheel to a mine, and the crater is still evident below the track assembly. (US Army)

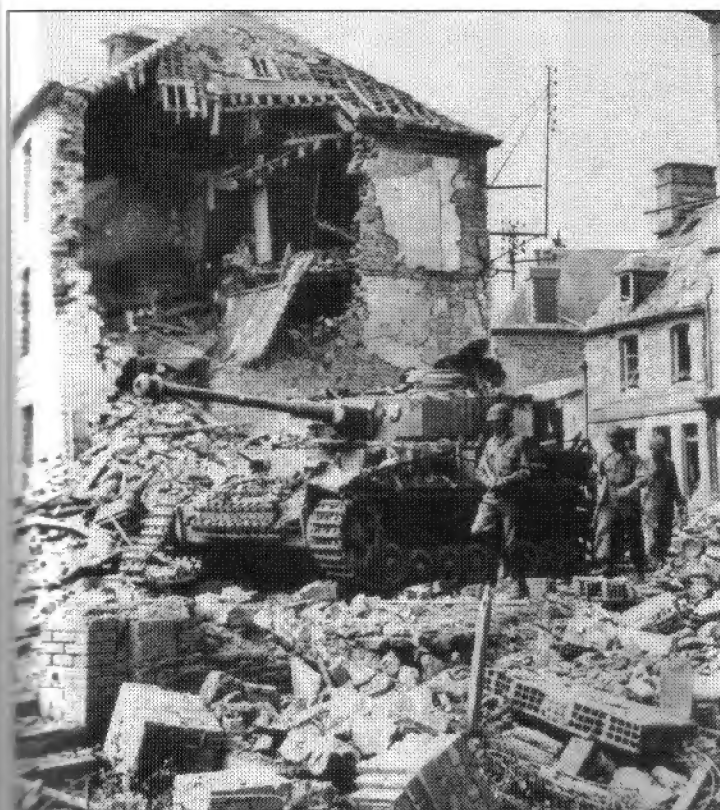
US infantry advance through the ruins of Pont de Farcy on 3 August 1944. The abandoned Pz.Kpfw. IV is believed to have been from the 2nd Panzer Div. and was apparently abandoned after losing its right track in the rubble. (US Army)

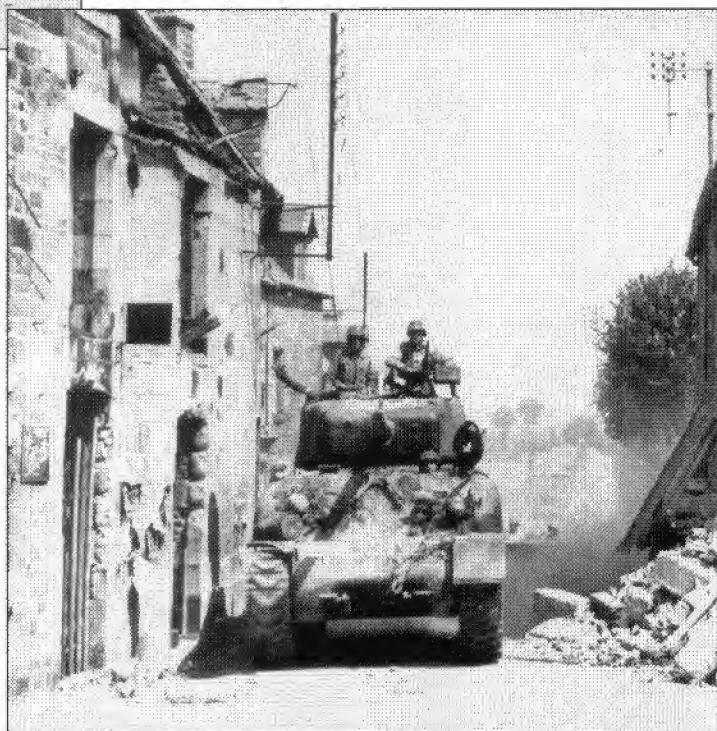
An M4A1(76) W medium tank of the 67th Arm'd. Regt., 2nd Arm'd. Div. enters St. Sever Calvados on 3 August 1944. The US Army began receiving its first 76mm-armed M4A1 tanks in June, immediately before the invasion but there was little initial enthusiasm for them due to their poor high-explosive projectile and the logistical complications of operating 75mm and 76mm gun armed tanks together. After meeting the Panther, the attitude quickly changed and units clamored to get more of these tanks as soon as possible. They were not very effective against the Panther except when firing "souped-up HVAP", a new type of high velocity projectile that was in short supply until 1945. (US Army)

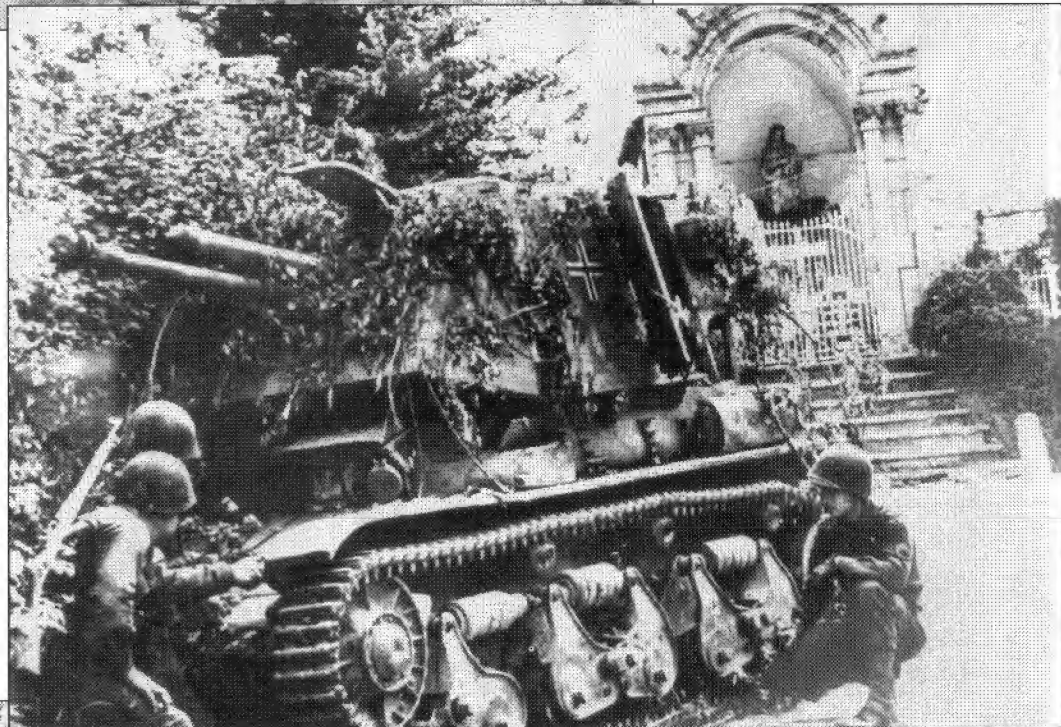
US infantry examine an abandoned 4.7cm PaK (t) auf Pz.Kpfw. Renault 35.R (f). This tiny tank destroyer consisted of a Czechoslovak 47mm anti-tank gun mounted on a turretless French Renault 35.R infantry tank. About 110 of these were in service during the Normandy fighting, and they were still capable of disabling a M4 medium tank from ambush. (US Army)

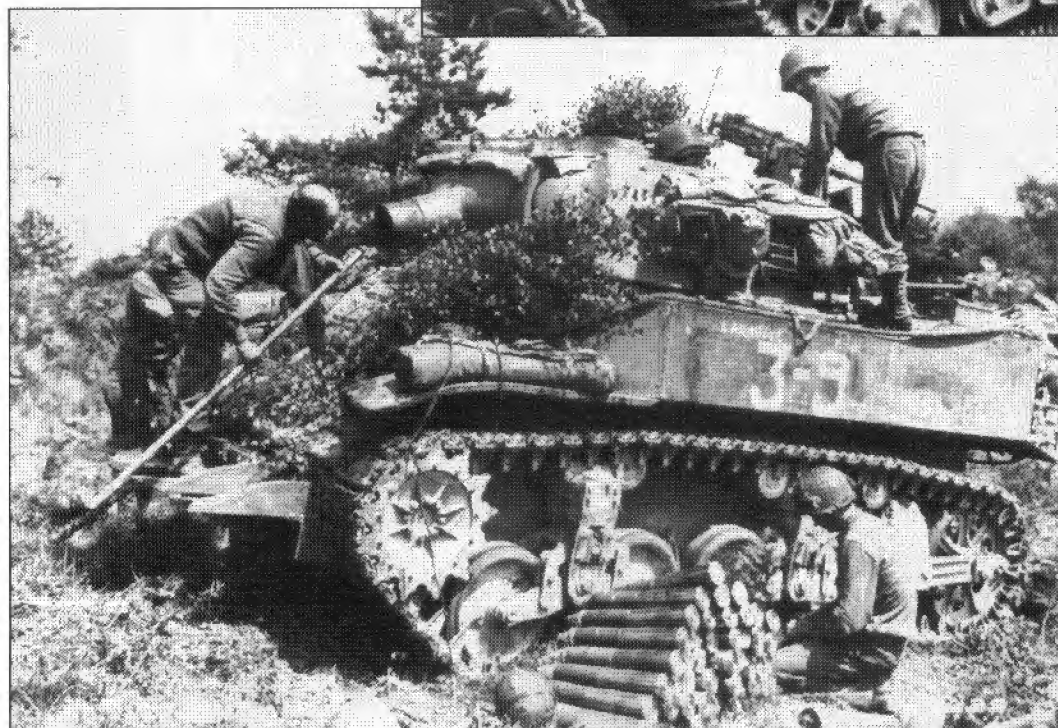
The crew of a M8 75mm HMC named "Laxative" of the 3rd Armored Div. prepare their vehicle for combat on 9 August 1944 during the fighting with the 2.Pz.Div and 1.SS-Pz.Div around Mortain. Notice that the vehicle is fitted with a Culin hedgerow cutter on the bow. The M8 was an assault gun version of the M5A1 light tank, substituting an open-topped turret with 75mm howitzer for the usual 37mm gun turret. They were deployed in armored infantry battalions for fire support in place of the older T30 75mm HMC after 1943. (US Army)

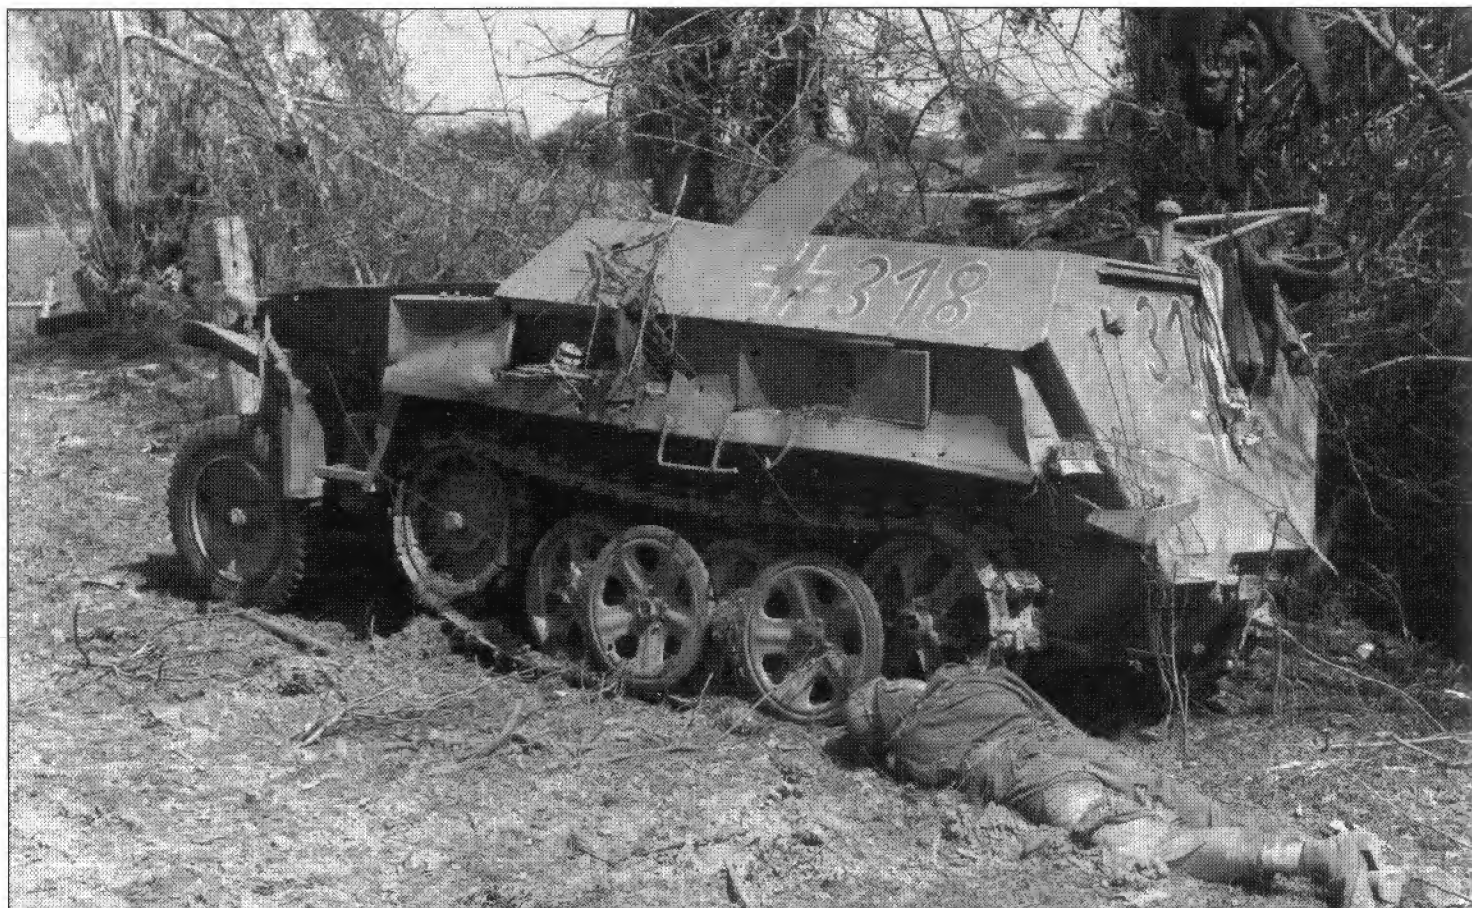
On 14 August, the remnants of the armored car battalion of the 2.Pz.Div. was ambushed by the 213th Tank Destroyer Bn. supporting the US 79th Infantry Div., destroying all of the unit's Sd.Kfz. 250 "Neu" half-tracks. These Sd.Kfz. 250 half-tracks were a smaller counterpart to the Sd.Kfz.251 troop carriers, and were used mainly in scouting and utility roles. The 2.Panzer Division insignia, a trident, is evident on the hull rear. (US Army)

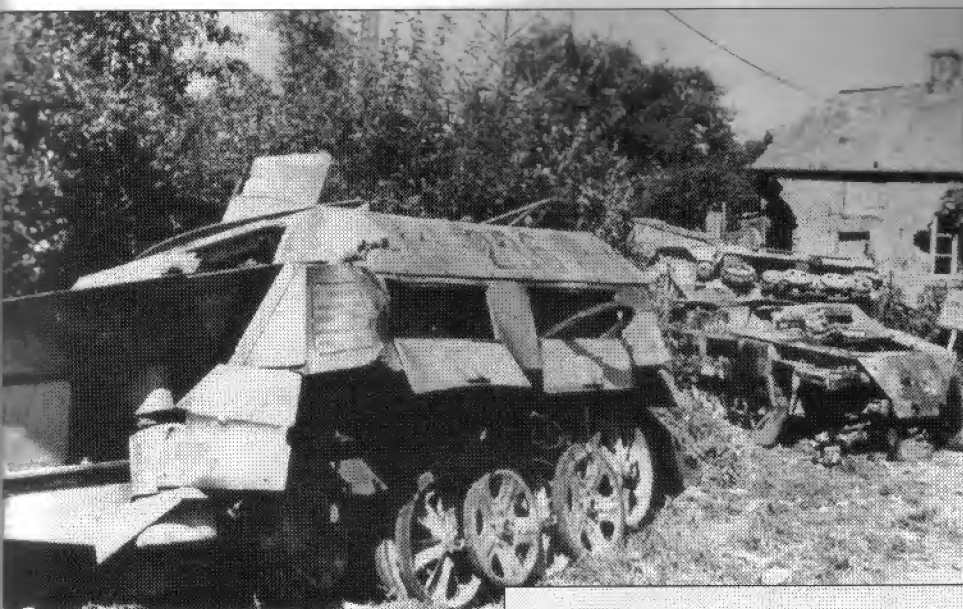
Another view of the knocked out half-track armored car unit from the 2.Pz.Div. on 14 August. As is evident in this view, the vehicle to the right was destroyed by two anti-tank gun penetrations on the bow plate. The vehicle in the foreground, from the 2nd company, has apparently taken several hits including one into the driver's visor. (US Army)

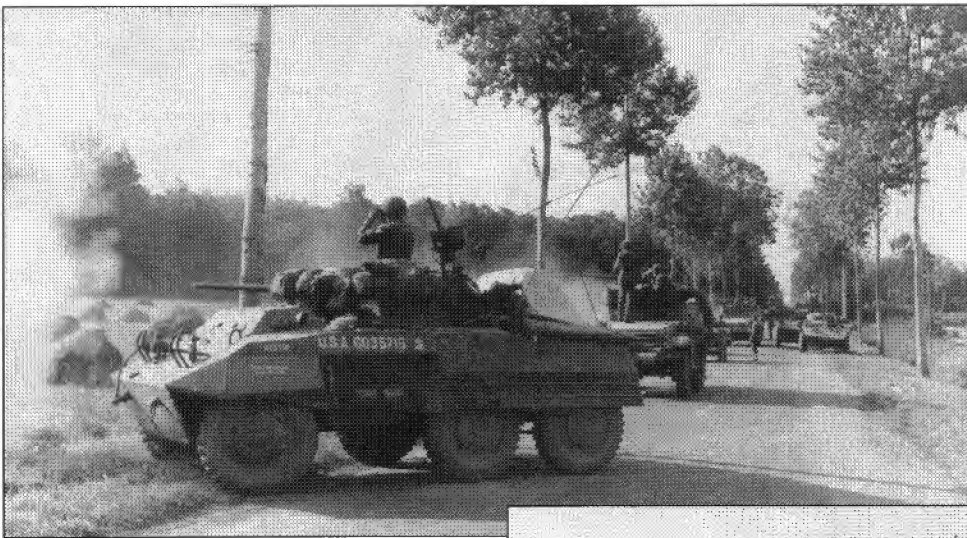
The Normandy campaign saw the combat debut of the M8 armored car, seen here during an engagement with Co. A, 23rd Infantry, 7th Arm'd. Div. near Epirnay on 27 August. The M8 armored car was used in recon and HQ units along with its unarmed utility variant, the M20 armored car, an example of which can be seen further down the column. The M8 was armed with a 37mm gun which proved adequate, since the M8 was not designed to fight enemy tanks. (US Army)

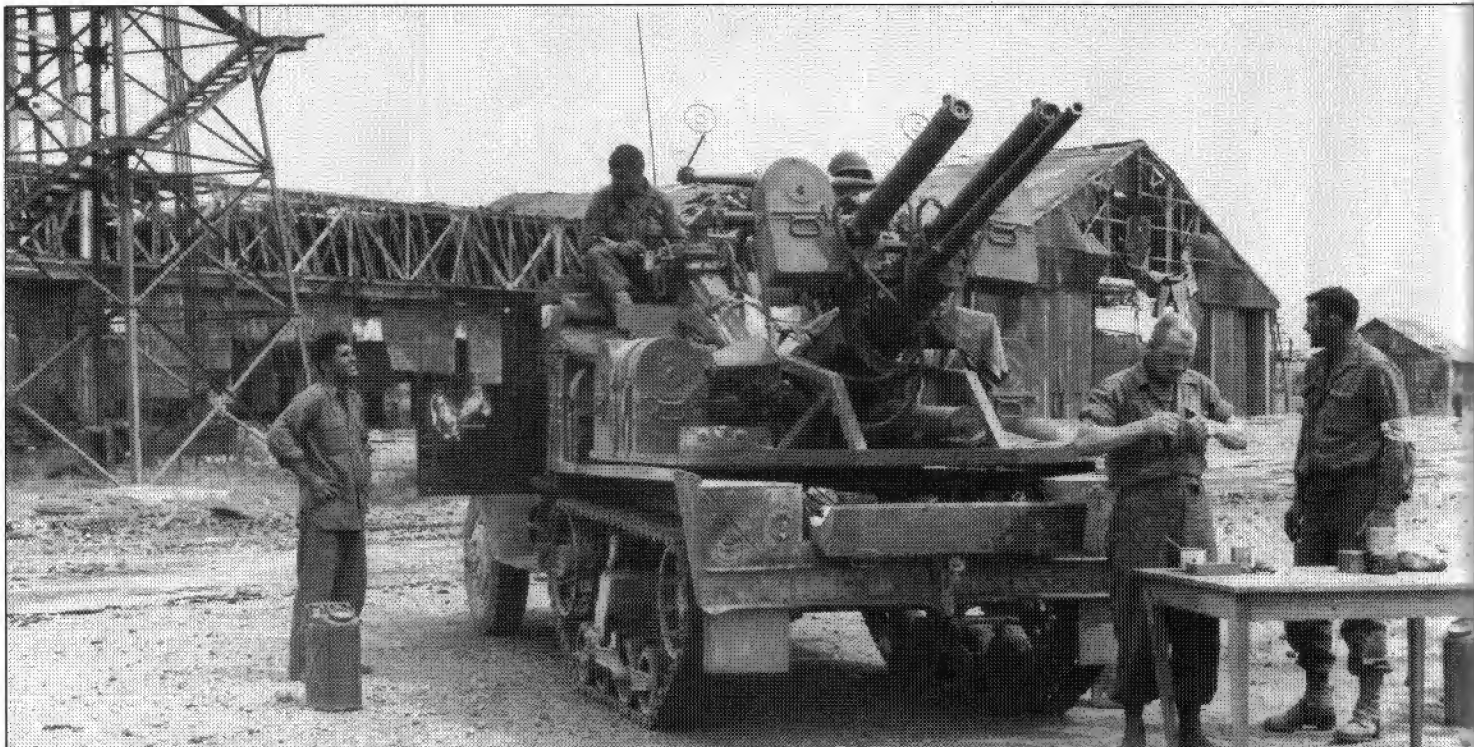
A T28 combination gun motor carriage of the 443rd AAA Bn. guards St. Rapheal air base in southern France on 17 August after the landings. The T28 was an expedient anti-aircraft vehicle rushed into service for the North African landings in 1942. A small number remained in service in the Mediterranean theatre, but in northwestern France, it had been replaced by the improved M15 and M15A1 CGMCs. (US Army)

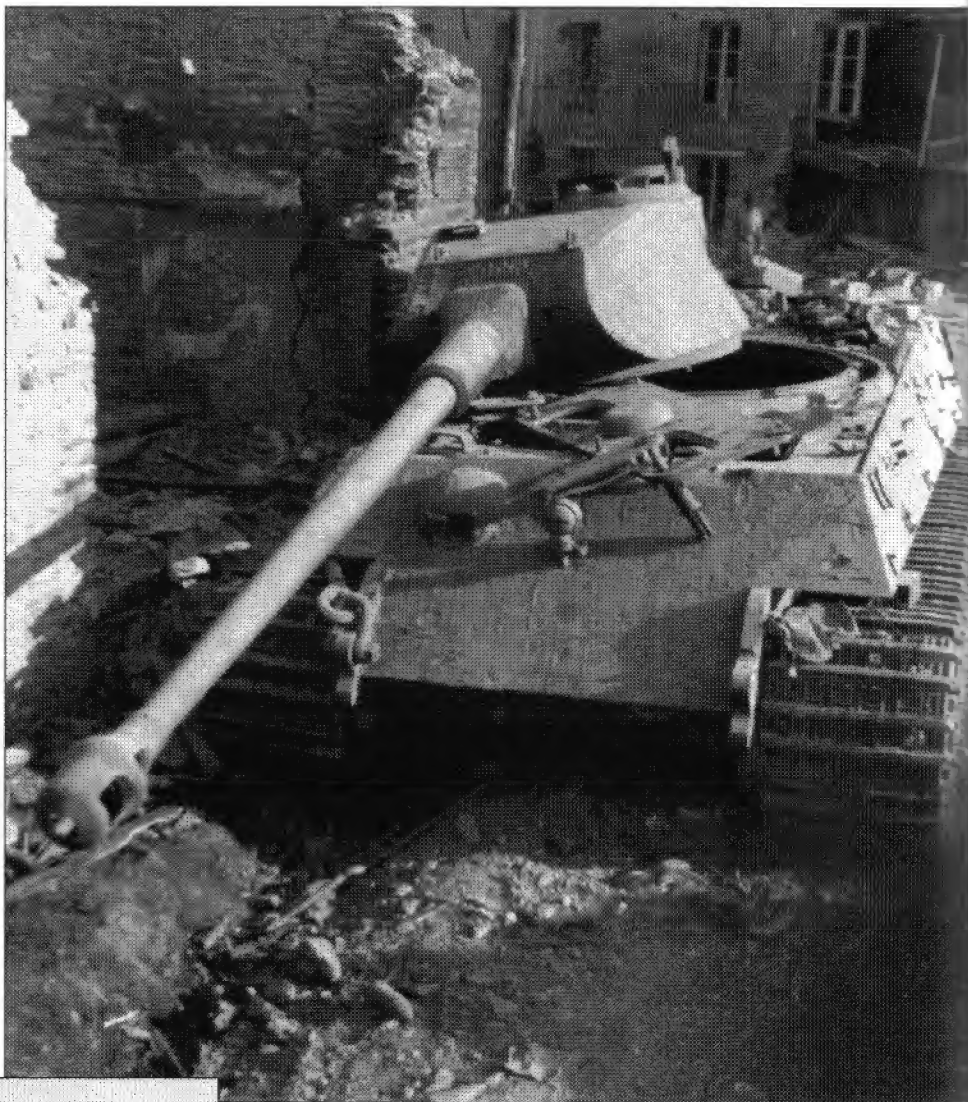
On 6 August, the town of le Plessis Grimoult, to the east of Mt. Pincon, was taken in a day-long hand-to-hand battle by the British 130th Brigade. Among the debris in the city was this King Tiger of s.Pz.Abt. 503. The tank has obviously suffered from an internal explosion which has knocked off its turret. It is unclear how this tank was knocked out; some sources indicate it was hit by rocket fire from a Typhoon. The King Tiger was the heaviest tank to see combat in Normandy, but it was new and suffered from serious technical shortcomings. Only two companies of this new tank were committed to the fighting, and all were lost by the end of August.

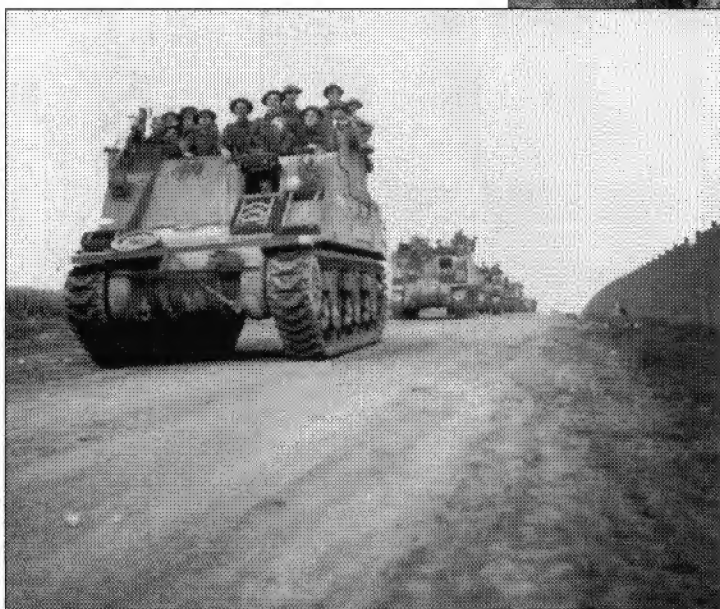
The stinging losses of infantry in the July fighting led the British to develop more satisfactory means to transport the forward waves of infantry. During the attack towards Falaise beginning on 8 August, Operation Totalize, the first use was made of improvised armored troop carriers, variously dubbed "holy rollers" or "defrocked priests". The names of course stemmed from the use of M7 Priest self-propelled howitzers for the conversion. By this time, the Royal Artillery was standardizing on the Sexton 25 pdr., so the Lend-Lease M7 Priests were converted to this role by removing the howitzer and adding bench seats. A similar conversion was made later using surplus Canadian Ram tanks, resulting in the Ram Kangaroos. (The Tank Museum)

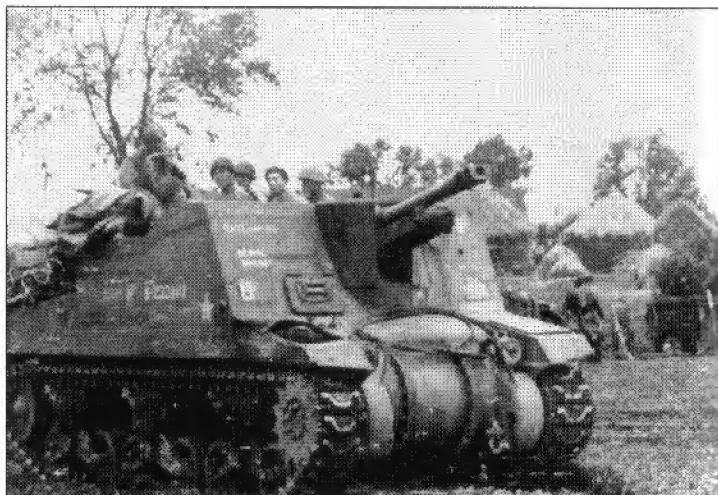
A Sexton 25 pdr. fires on German positions during the opening phase of Operation Totalize on 8-9 August 1944. The Sexton was the British equivalent of the US Army's M7 105mm HMC, but used the standard British 25 pdr. instead. This is a vehicle of the 1st Polish Armoured Division named "Raclawice" after the famous 18th Century battle where Tadeusz Kosciuszko led a peasant army to defeat the Tsarist Russian forces. (Sikorski Institute)

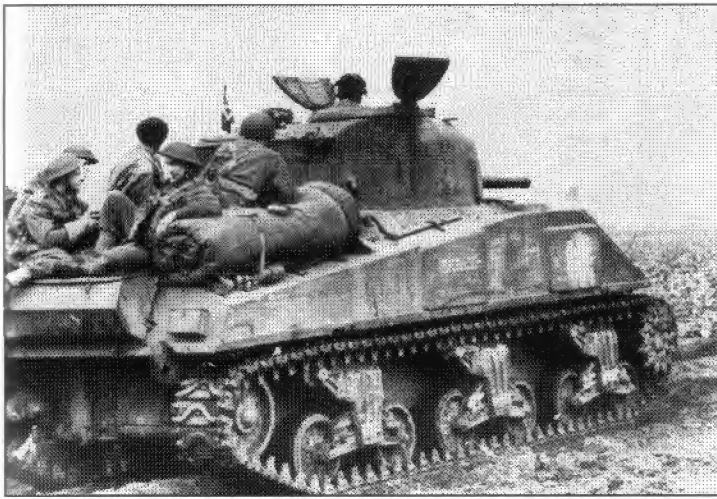
A Sherman V of the 1st Polish Armoured Division moves forward towards Falaise during Operation Totalize. The Polish 1st Armoured Div. and the Canadian 4th Armoured Div. were the spearheads of the British drive, due to the heavy losses that the three British armoured divisions had suffered during the fighting around Caen in July. Notice that the Allied star insignia has been painted over on this tank, as such insignia made attractive aiming points for German anti-tank gunners. (Sikorski Institute)

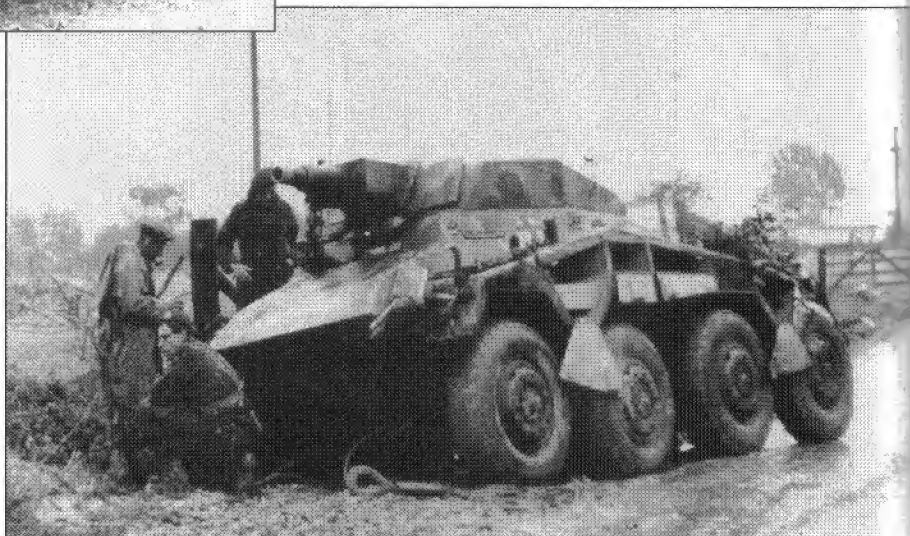
The Falaise Gap was filled with abandoned or destroyed equipment that had to be left behind by the retreating German forces. This is a 15 cm Panzerwerfer 42 auf SF (Sd.Kfz. 4/1), a 105mm multiple rocket launcher based on an armored version of the Opel Maultier half-track truck. (US National Archives Federal Records Center-Suitland)
